REFERENCE:  
BULLETIN 54-48

**DC-10**

SUBJECT: NACELLES/PYLONS - Attach Fittings - Replace Engines 1 And 3 Wing Pylon  
Aft Attach Spherical Bearings.

MODEL: DC-10, Series 10, 30, and 40.

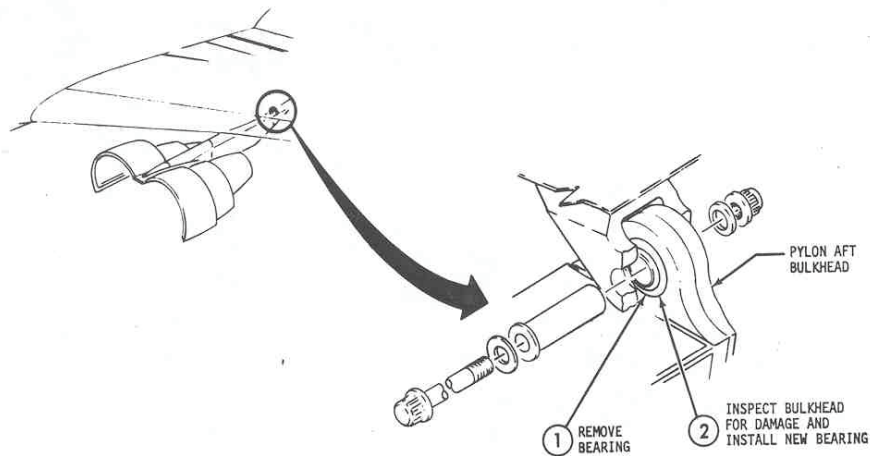
FIGURE 1

- ② VISUALLY INSPECT BULKHEAD FOR EVIDENCE OF DAMAGE DUE TO GOUGING OF BEARING INTO BULKHEAD AND ACCOMPLISH THE FOLLOWING:

- b. IF DAMAGE IS EVIDENT OR HOLE SIZE EXCEEDS 2.9990(76.1746)-INCH DIAMETER, ENLARGE HOLE IN BULKHEAD IN INCREMENTS NOTED AS REQUIRED TO CLEANUP DAMAGE, CHAMFER BOTH HOLE EDGES .045+.010(1.143+.254) X 45° USING APPLICABLE REAMER AND CUTTER FROM DZZ7244-1 "C" TOOL SET. SEE TABLE 1. (SEE MAINTENANCE MANUAL CHAPTER 54-00-00, PARAGRAPH ENTITLED "REMOVE PYLON.")

FINAL HOLE SIZE	REAMER	CUTTER	APPLICABLE BEARING
3.0005/3.0010 (76.2127/76.2254)	DZZ7244-29	DZZ7244-35	KMS1005 (.002(.0508)-INCH OVERSIZE)
3.0085/3.0090 (76.4159/76.4286)	DZZ7244-31	DZZ7244-37	KMS1006 (.010(.2540)-INCH OVERSIZE)
3.0185/3.0190 (76.6699/76.6826)	DZZ7244-33	DZZ7244-39	KMS1007 (.020(.5080)-INCH OVERSIZE)
3.0285/3.0290 (76.9239/76.9366)	DZZ7244-3	DZZ7244-5	KMS705 (.030(.7626)-INCH OVERSIZE)
			OR
			LH22F
			OR
			79828

- ① REMOVE KSBY22N1, ATBY22V4, BLFR22-034, YTA301, 76689, LHSS22-77, LHSSR22-77, OR KSBY22-2 BEARING USING DZZ7237-1 WING PYLON AFT BEARING REMOVAL SET TOOLS AND HP-60G ENERPAC PUMP AND CYLINDER SET. (SEE MAINTENANCE MANUAL CHAPTER 54-00-00, PARAGRAPH ENTITLED "REMOVE PYLON", STEP 43b.)

- a. IF DAMAGE IS NOT EVIDENT, MEASURE HOLE IN BULKHEAD. IF HOLE SIZE IS 2.9985/2.9990(76.1619/76.1746)-INCH DIAMETER INSTALL NEW KSBY22-5, BSSR-22220, NSS22D, OR 79583 BEARING USING DZZ7237-1 WING PYLON AFT BEARING TOOLS AND HP-60G ENERPAC PUMP AND CYLINDER SET. (SEE MAINTENANCE MANUAL CHAPTER 54-00-00, PARAGRAPH ENTITLED "REMOVE PYLON", STEP 43c.)

NOTE: IF HOLE SIZE IS GREATER THAN 2.9990(76.1746)-INCH DIAMETER, OVERSIZE BEARING MUST BE INSTALLED PER STEP 2b.
